# WARTIME REPORT

FLIGHT MEASUREMENTS OF THE EFFECT ON ELEVATOR STICK FORCES

MEMORANDUM REPORT

By Harold I. Johnson and Robert G. Mungall

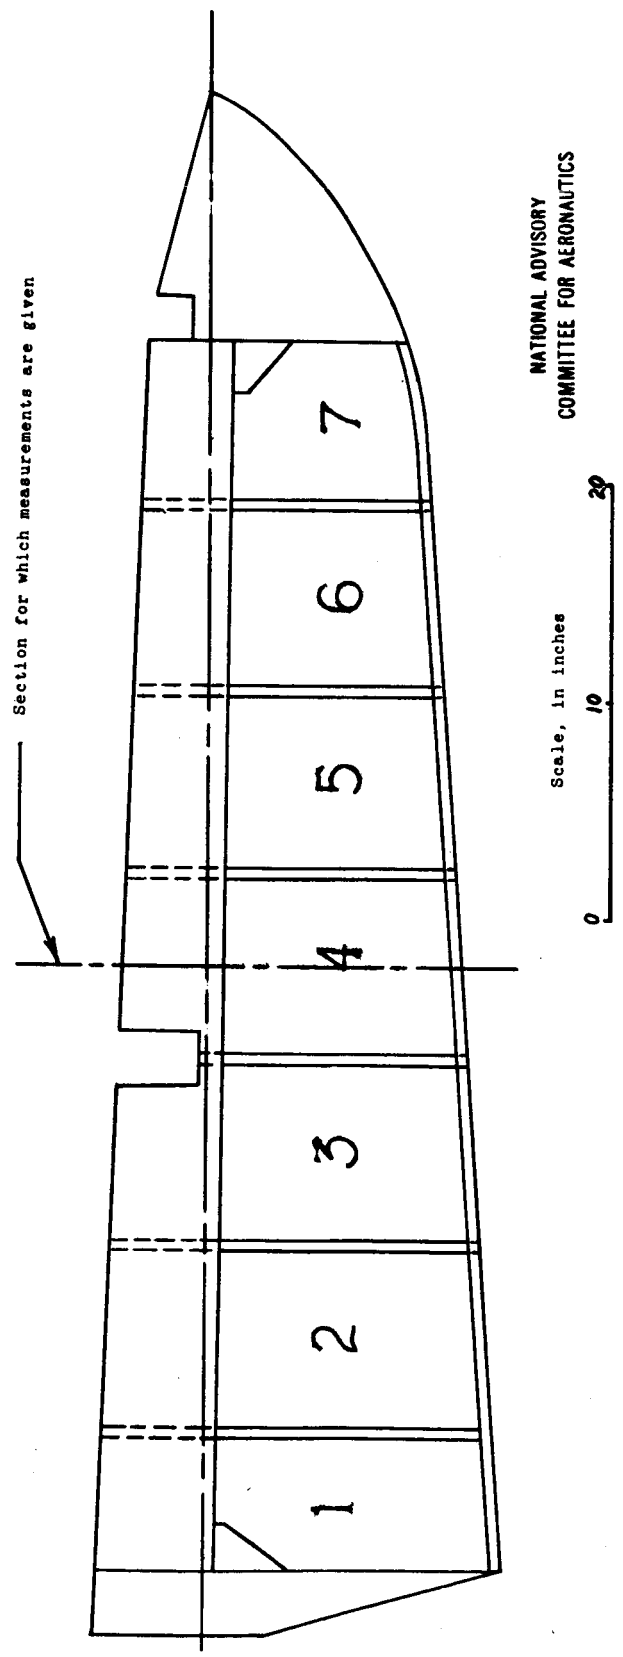
center lines. The dimensions of the elevators are given in table I under column A. No measurements of the elevator fabric distortion were obtained in these initial tests. Later, another P-63A-1 airplane (AAF No. 42-68889) having the same stabilizer incidence and type of elevators, except for a minor change in plan form at the inboard end (compare in figs. 1 and 3), was tested briefly to obtain pictures of the elevator fabric distortion characteristics. The dimensions of the horizontal tail of the second airplane tested are given in column B of table I. The elevators of the second airplane tested had an average fabric tension of 3 pounds per inch as measured by an NACA instrument for determining fabric tension. As would be expected, the two airplanes had nearly identical elevator stick-force characteristics. Finally, measurements were repeated with airplane number 42-68889 after the stabilizer incidence had been reduced from  $2.7^\circ$  up from the thrust axis to  $1.1^\circ$  up from the thrust axis and the elevator rib spacing had been cut in half (fig. 4). The fabric tension was not measured on the latter elevator because the only instrument available for measuring fabric tension was too large to be used on panels formed by ribs spaced  $4\frac{1}{4}$  inches apart.

Figure 3.- Planform of P-63A-1 normal short-chord elevator showing rib locations and extent of unsupported fabric panels.

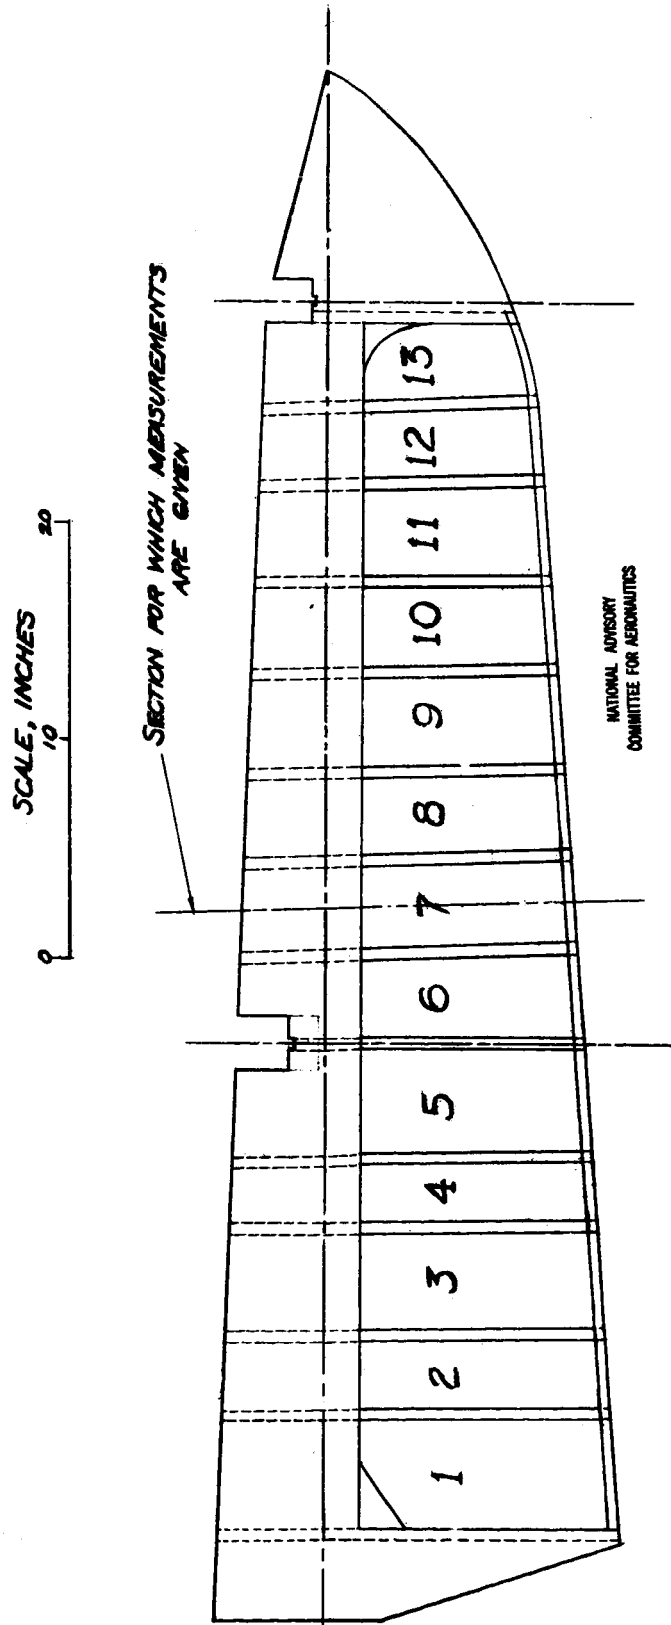
FIGURE 4.-PLANFORM OF P-63A-1  
NORMAL SHORT-CHORD HALF-RIB-SPACED  
ELEVATOR SHOWING RIB LOCATIONS AND  
POSITIONS OF UNSUPPORTED FABRIC  
PANELS.
